<b>NASA Engineering and Safety Center Technical Report</b>	Document #: <b>RP-07-47</b>	Version: <b>5.1</b>
Title:	<b>STS-117 Hail Damage Repair Assessment</b>		Page #: 1 of 114

# **Space Transportation System (STS)-117 External Tank (ET)-124 Hail Damage Repair Assessment**

**May 24, 2007**

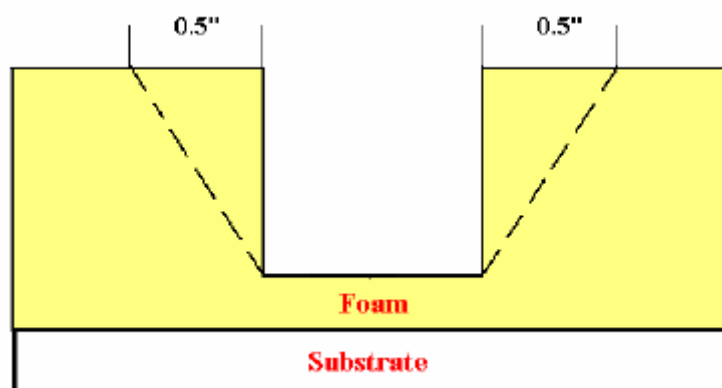
**Figure 6.2-2. Sand and Blend Wall Angles for Defects > 0.1” Deep [ref. 24]**

dye was not applied to defects before the crushed NCFI was removed. If the final defect depth did not exceed 0.3 inch and no crack-like indications were evident, red dye was not applied after the sand-and-blend repair was completed. The result of these variations is an increase in the potential for day-of-launch ice formation at sand and blend repair locations, and an increased risk for undetected crushed foam at some locations.

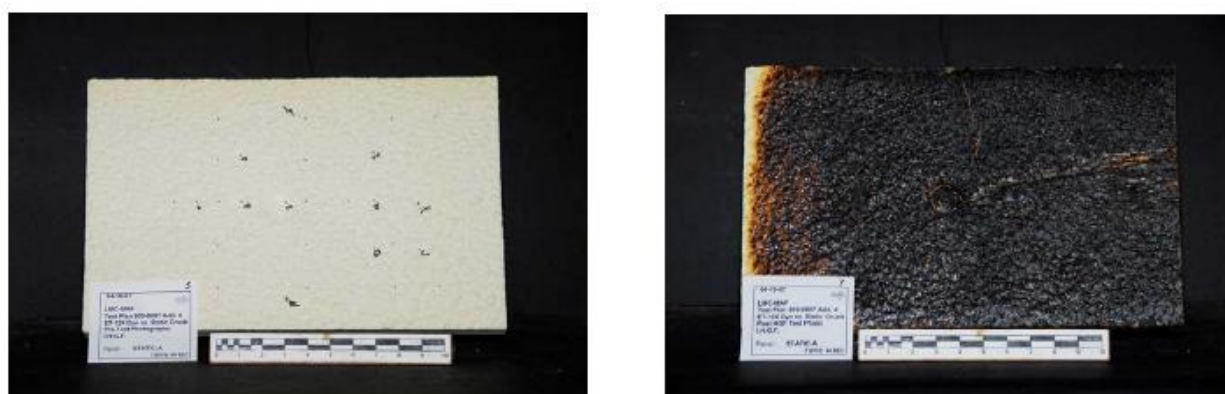
**Figure 7.2-1. Hot Gas Test of NCFI Panel Subjected to Static Loads Simulating STS-117**  
[ref. 8]

envelope the STS-117 hail event due to significant differences in magnitude, rate, and cross-sectional area over which energy was dispersed in those test articles, NESC recommended additional tests be conducted on panels designed to simulate the STS-117 damage. These tests showed a linear relationship between energy of impact and depth of TPS damage consistent with the STS-96 results, with the bulk of the crushed foam found within about 0.2 inch of the defect bottom [refs. 5, 24]. Hot gas tests were conducted on un-repaired NCFI panels subjected to STS-117 simulated damage (both static and dynamic) and no significant debris release was observed [ref. 8]. Recession rates for these panels were in-family.

On the basis of these tests, NESC concurs that significant debris release or accelerated TPS recession due to residual crushed foam is unlikely.

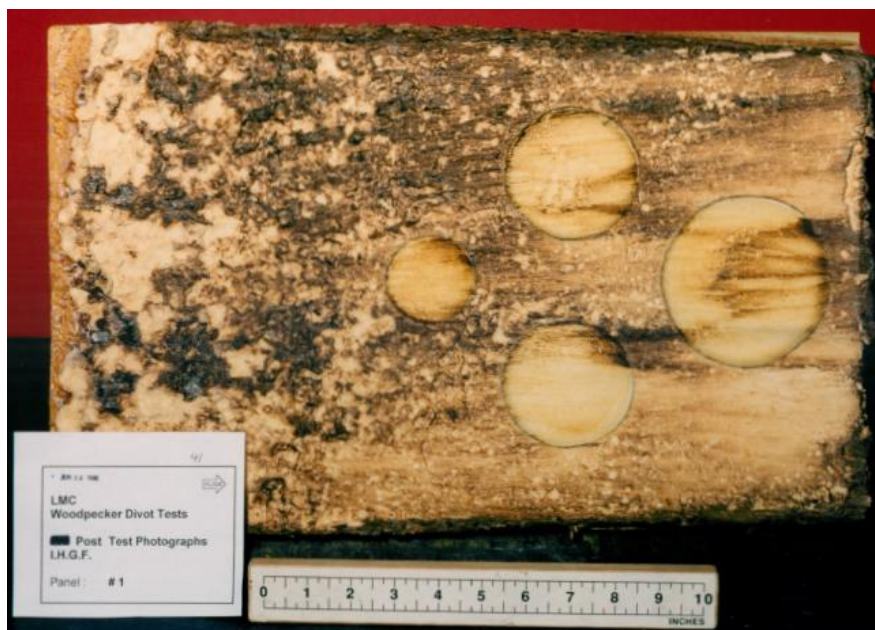
**Figure 7.3-3. STS-70 Multiple PDL Repair Test Panel [ref. 3]**

Over 900 PDL repairs were made on the ET LO2 tank, which is approximately an order of magnitude more than normal. In general, the specified PDL repair density limits (repairs per square foot and distance between repairs) have been test-validated and demonstrated to have no effect on NCFI integrity.

PDL material used on ET-124 had to be requalified due to a vendor change. Testing done to support the requalification also demonstrates acceptable performance of multiple PDL and S&B repairs in an environment similar to that expected on the LO2 tank at ascent [ref. 5].

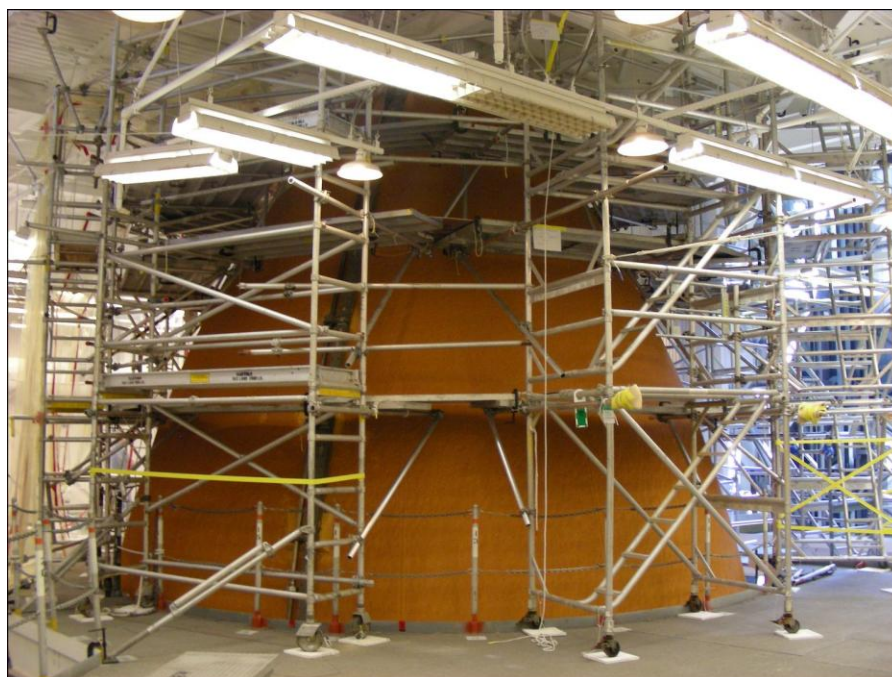
**Figure 7.3-5. ET-124 Access and Lighting in the VAB**

Training, work area access, and lighting were reviewed. The PDL repair certification / re-certification procedures used at KSC and MAF are slightly different. Most notably, the KSC training procedures do not include steps for dissection and analysis of PDL repairs, and the test panels used for KSC training are not made with NCFI foam. While access to the work area was adequate, NESC noted the lighting in the LOX ogive work area was insufficient for some tasks such as inspection of Conathane® application and identification of damaged foam prior to red dye application. NESC recommended improvements to lighting in the work areas, and that recommendation was accepted and implemented.

temperature is specified, the procedures did not include verification steps to ensure this pour time was not exceeded and recommended quality inspector timing of multiple PDL pours from a single syringe to the procedure development team. The team also recommended that red dye application procedures be strengthened with specific work steps in lieu of notes. These recommendations were subsequently implemented.

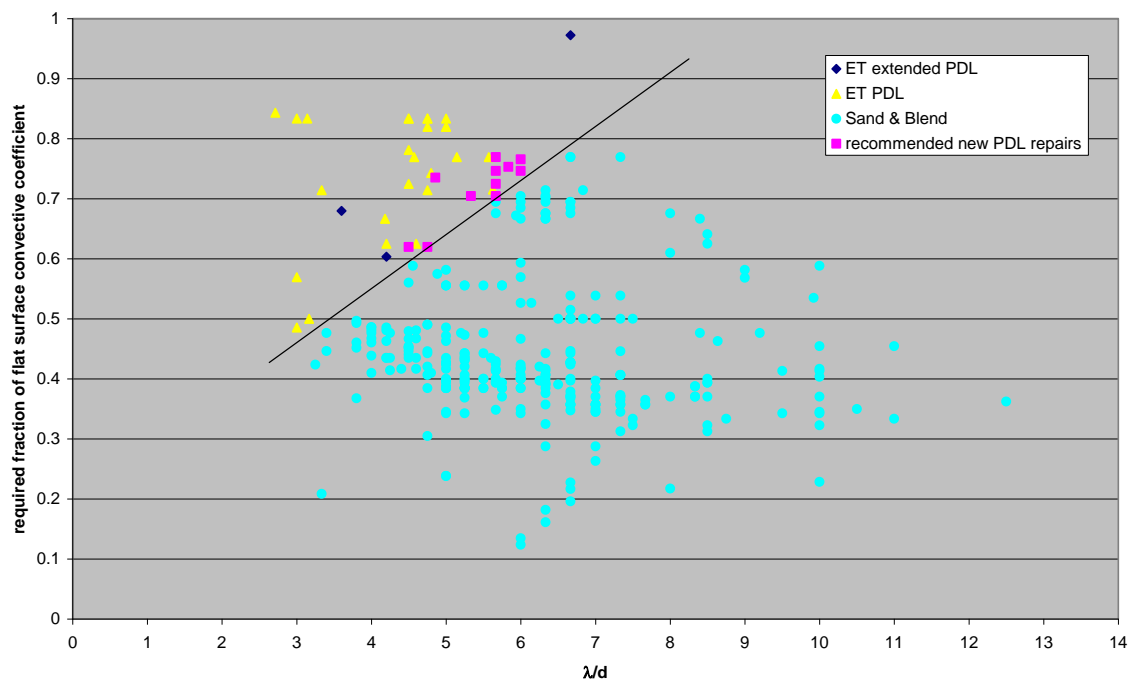
**Figure F-6 – Repair Sorting and Recommended Augmentation**

Figure J-6 also shows 11 repairs that were recommended as S&B by the ET Project that are above the dividing line and thus have icing potential that exceeds that of sites that had been designated for PDL repair. The NESC recommended to the project that these sites also be repaired with PDL. The ET Project accepted the recommendation.

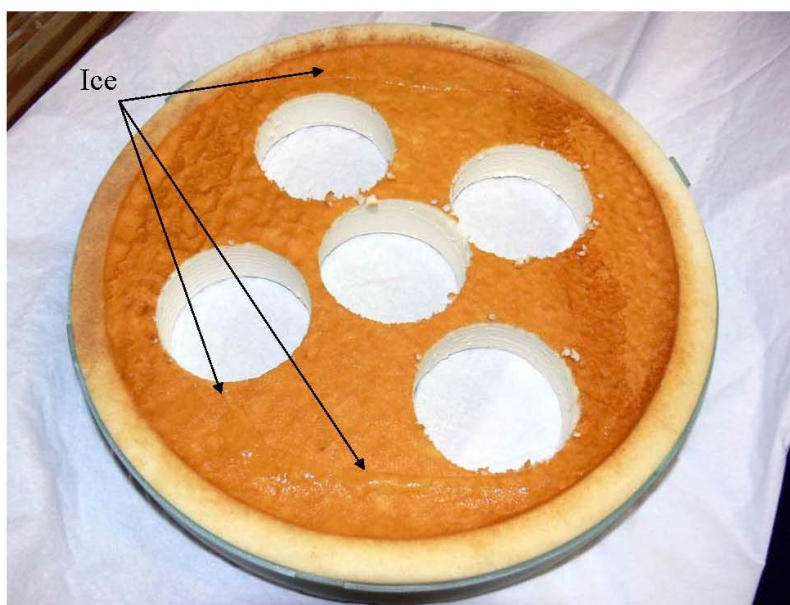
Figure 5. Photograph of 15 month weathered BX-265 foam immediately after all core sections were taken. Note that ice from CMU testing was still present.

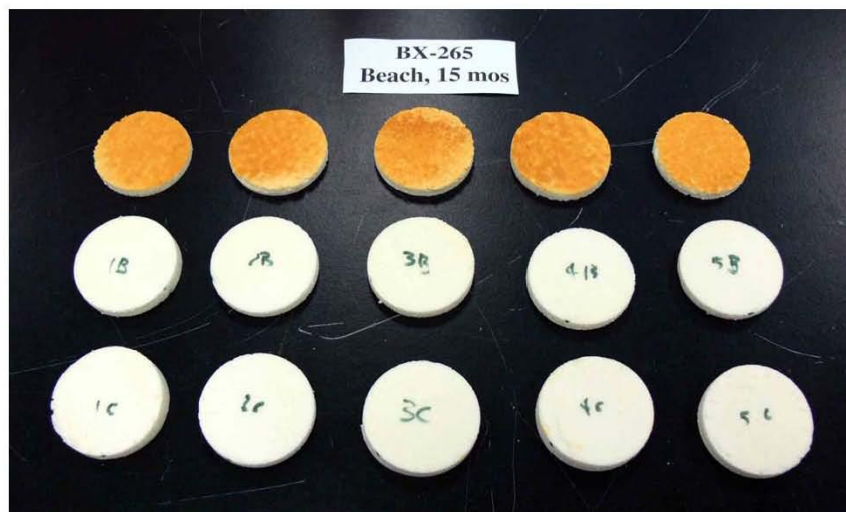
Figure 6. Photograph of dissected cores of BX-265 15 month weathered after drying.

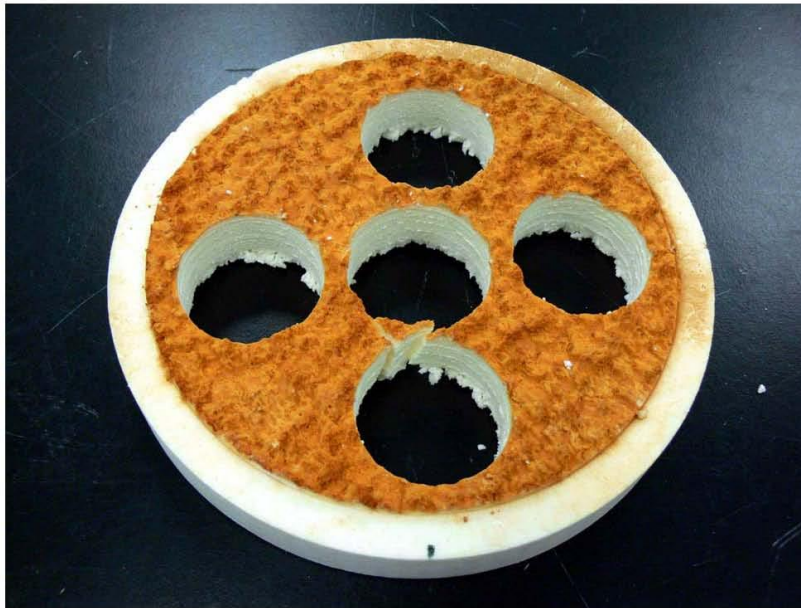
Figure 9. Photograph of 15 month weathered net spray NCFI 24-124 after coring and drying overnight.

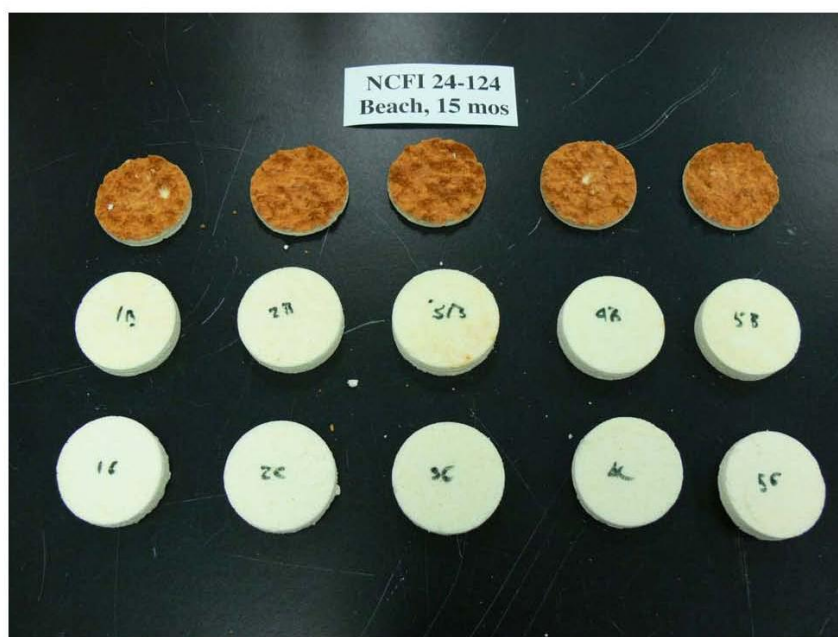
Figure 10. Photograph of dissected cores of net spray NCFI 24-124 15 month weathered samples after drying.

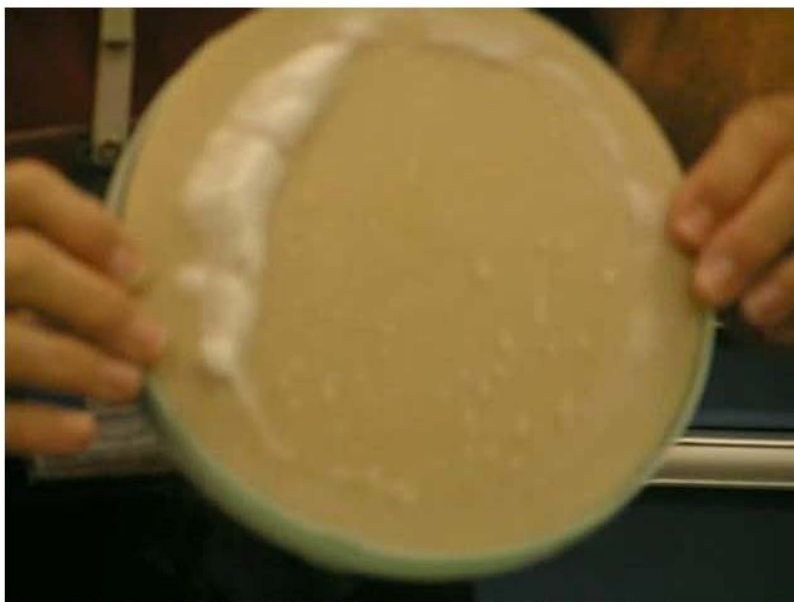
Figure 12. A photographs of GFT flexible polyimide foam immediately after removal from Cryogenic Moisture Uptake test apparatus. Note the ice/frost and water drops evident on the warm surface.

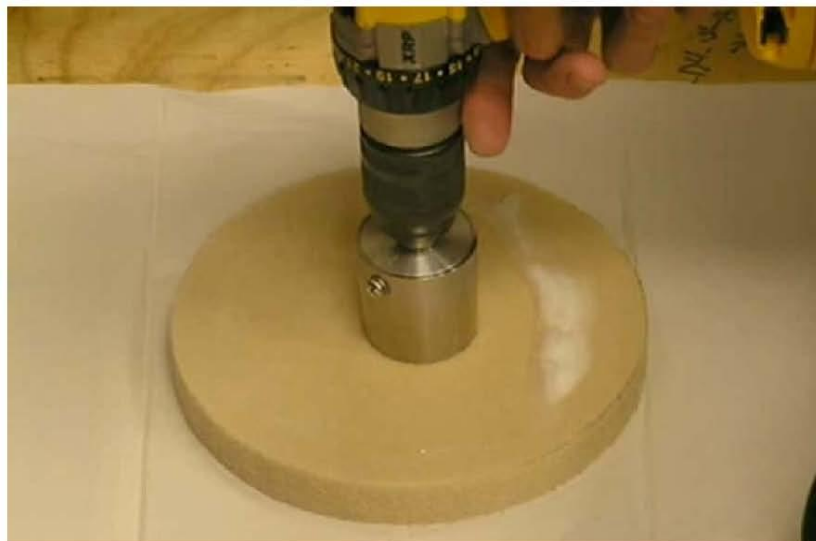
**Figure 13. A photograph two minutes after removal from CMU apparatus the first core was drilled out. Note the ice/frost section.**

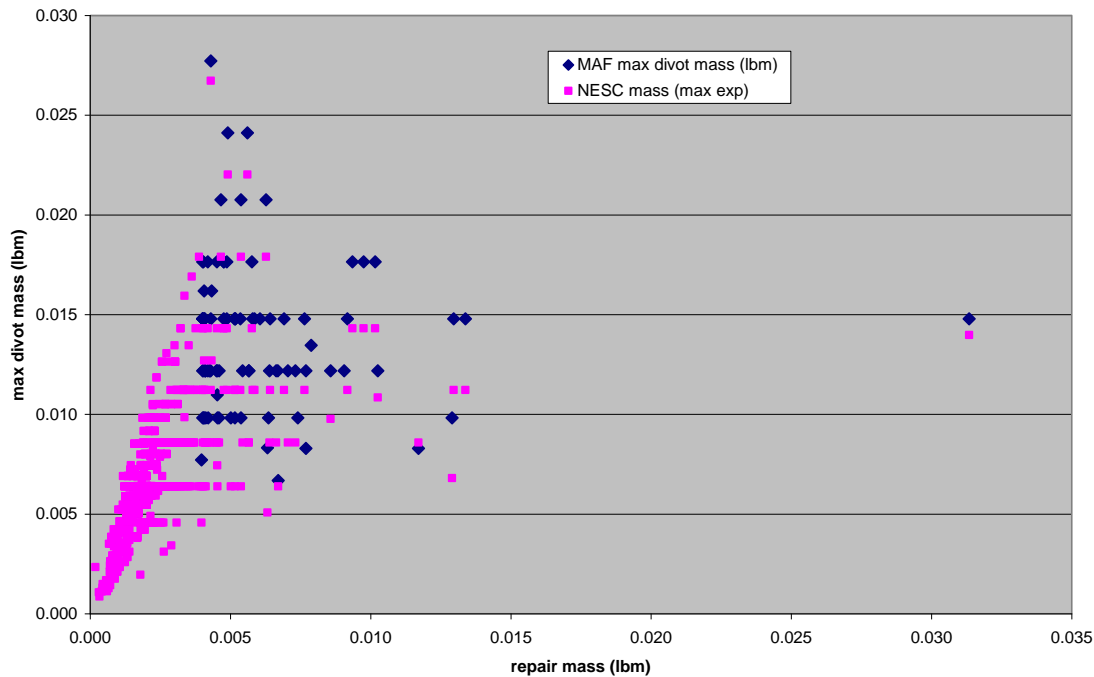
**Figure I-1 - Maximum Expected Divot Masses Using the Two Algorithms**

Figure L-1 plots the divot masses generated by the ET Project analysis and the NESC analysis. Even the figure shows that a very large number of possible divots greater than the deterministic limit of 0.004 lbm are not calculated are by the ET Project's algorithm.

Using the NESC method allows all the maximum expected divots that exceed 0.004 lbm to be captured, generating the most accurate possible input to the PRA. The NESC recommended to the Space Shuttle Systems Engineering and Integration (SE&I) Office that the NESC method be used to capture the maximum expected divot masses from the PDL 1034 repairs. The SE&I Office accepted the recommendation.

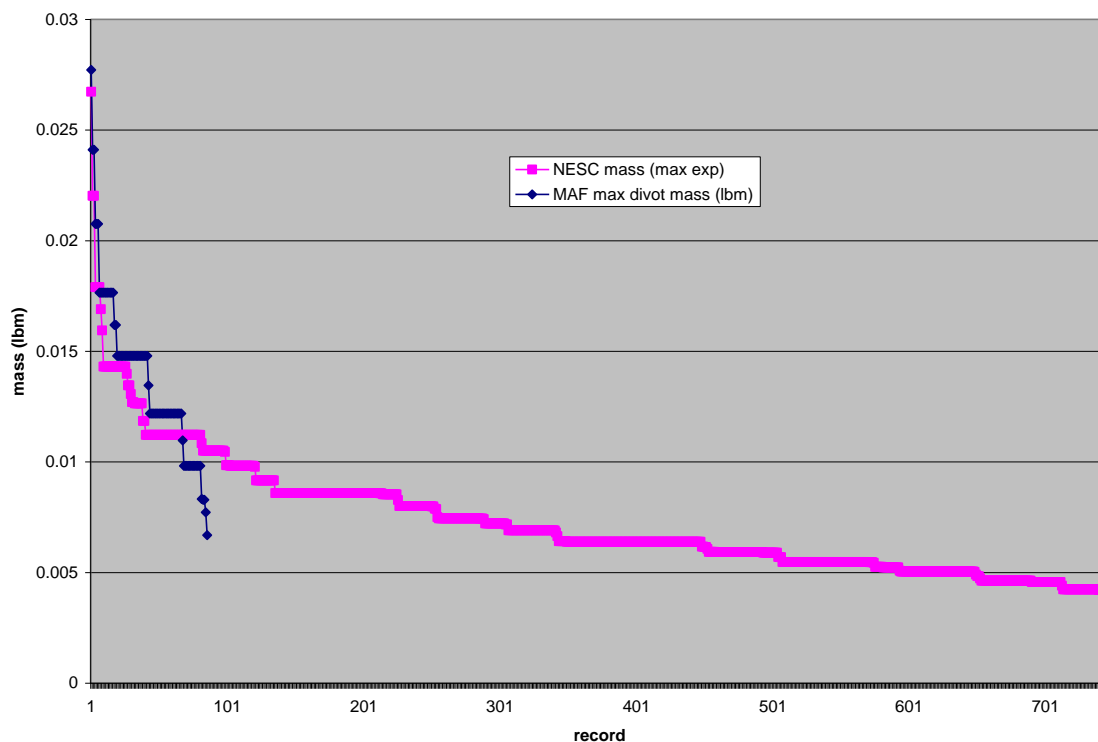
Figure L-2 – Sorted Divot Masses

Figure L-2 plots sorted defect masses greater than 0.004 lbm obtained by the two algorithms. The figure shows the additional smaller masses between 0.004 and 0.010 lbm that are captured by the NESC method.
